D-168

Realty Building
East New Market
private

Maryland Historical Trust State Historic Sites Inventory Form

historic REALTY BUILDING

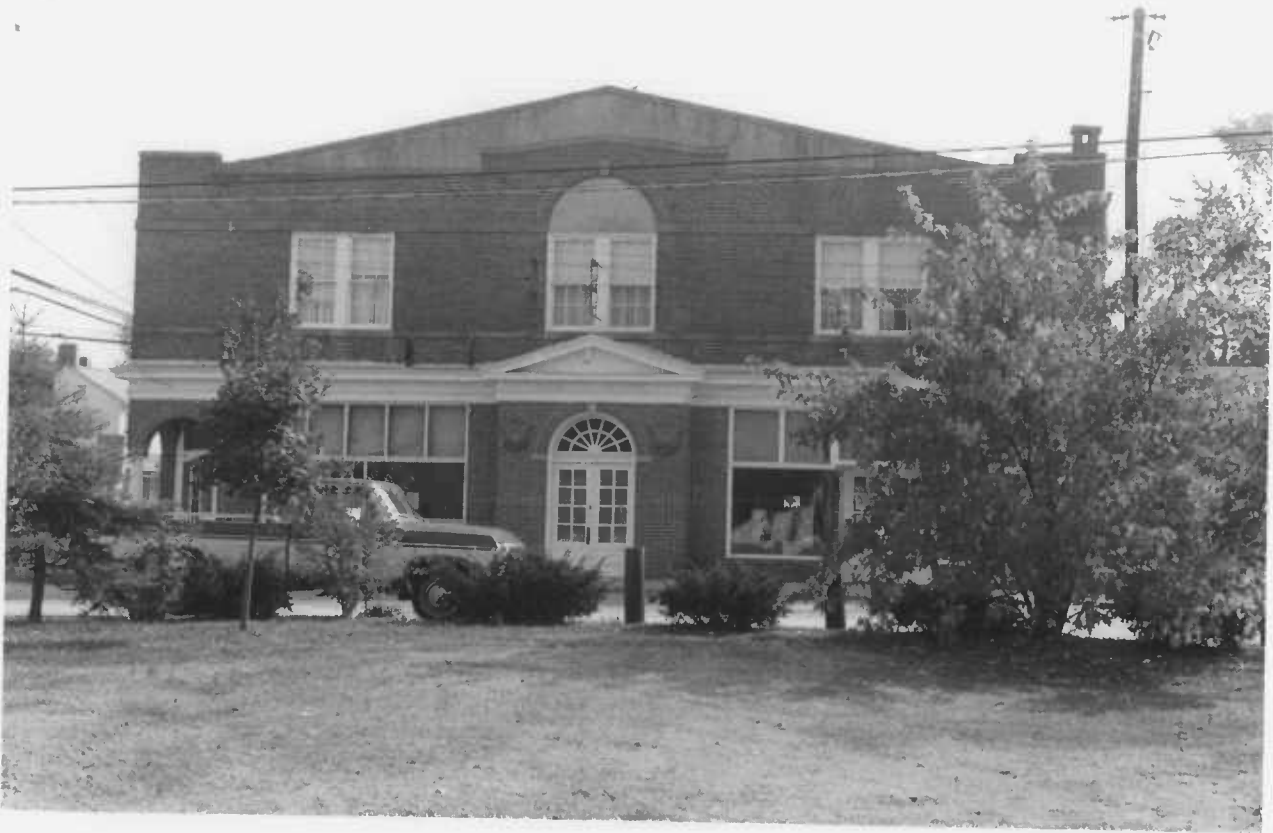
West elevation

The west (main) elevation is a basically symmetrical three-bay facade with a center entrance and flanking storefronts. The glazed double-door entrance, incorporated within a slightly projecting gabled vestibule, is topped by a round arched transom of radiating muntins. The gable pediment above the doorway lines up with a mid-level cornice that stretches along the street elevations. The storefront south of the center doorway is marked by a recessed entrance and flanking plate glass display windows. A series of smaller, frosted windows line the top of the glazed area. The storefront to the north is slightly different with the entrance located in the corner of the building, and a pier marks the outside corner of the structure. The second floor of the west facade is marked by three paired six-over-six sash windows with the center bay distinguished by a arched transom. Concrete stringcourses, which stretch across the second floor elevation, line up with the upper and lower edges of the windows. The original brick parapet wall has been modified with a slight raising of the center wall area in contrasting concrete.

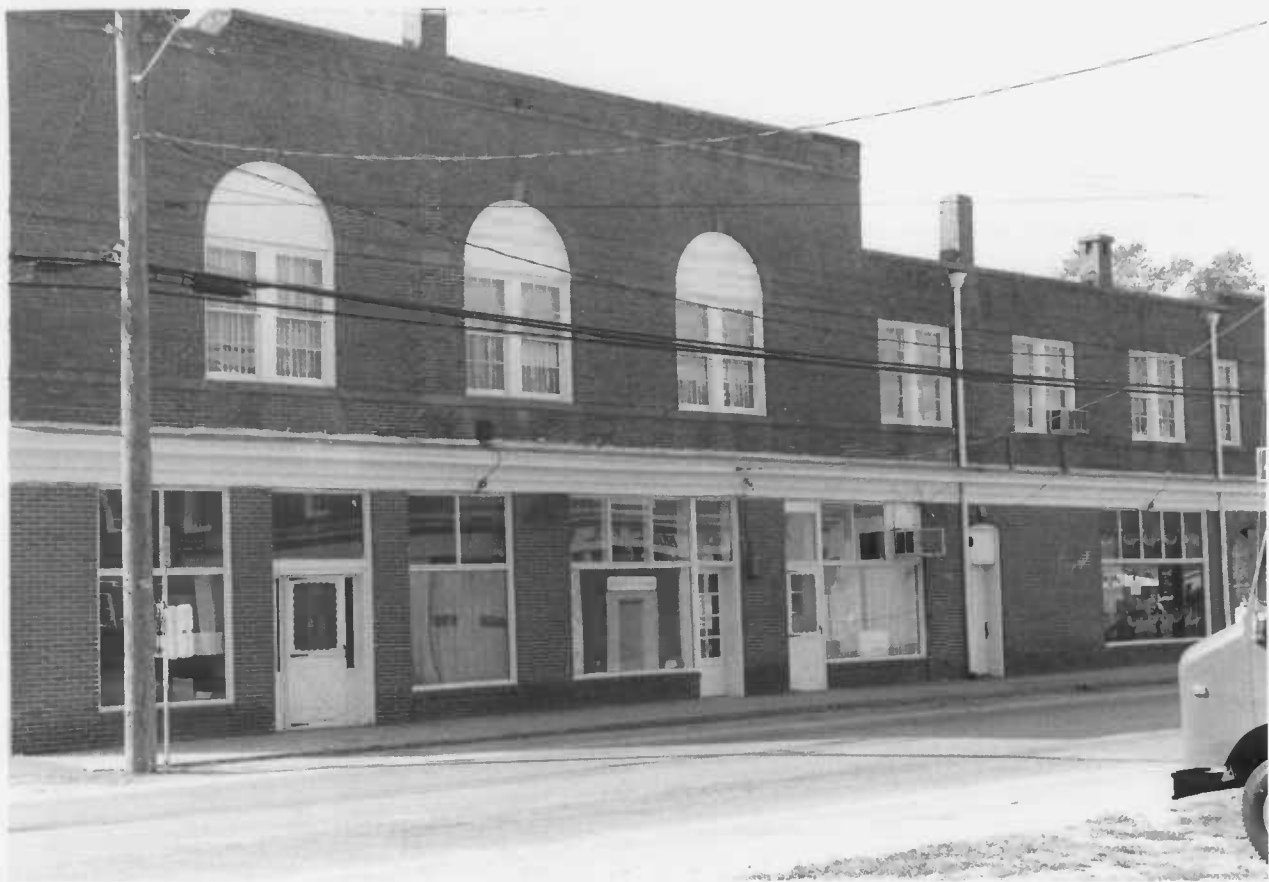
REALTY BUILDING D-168
East New Market, Dorchester Co., MD
North elevation
10/87 Paul Touart photographer
Negative/MD Historical Trust

The north side of the structure is divided into four storefronts on the first floor and seven uneven bays on the second floor. Each storefront has a recessed entrance and flanking plate glass display windows. The second floor is lighted by a combination of paired and single six-over-six sash windows with concrete keystones fixed in the round arch that frames each window transom. The north facade is highlighted by a concrete stringcourse as well.

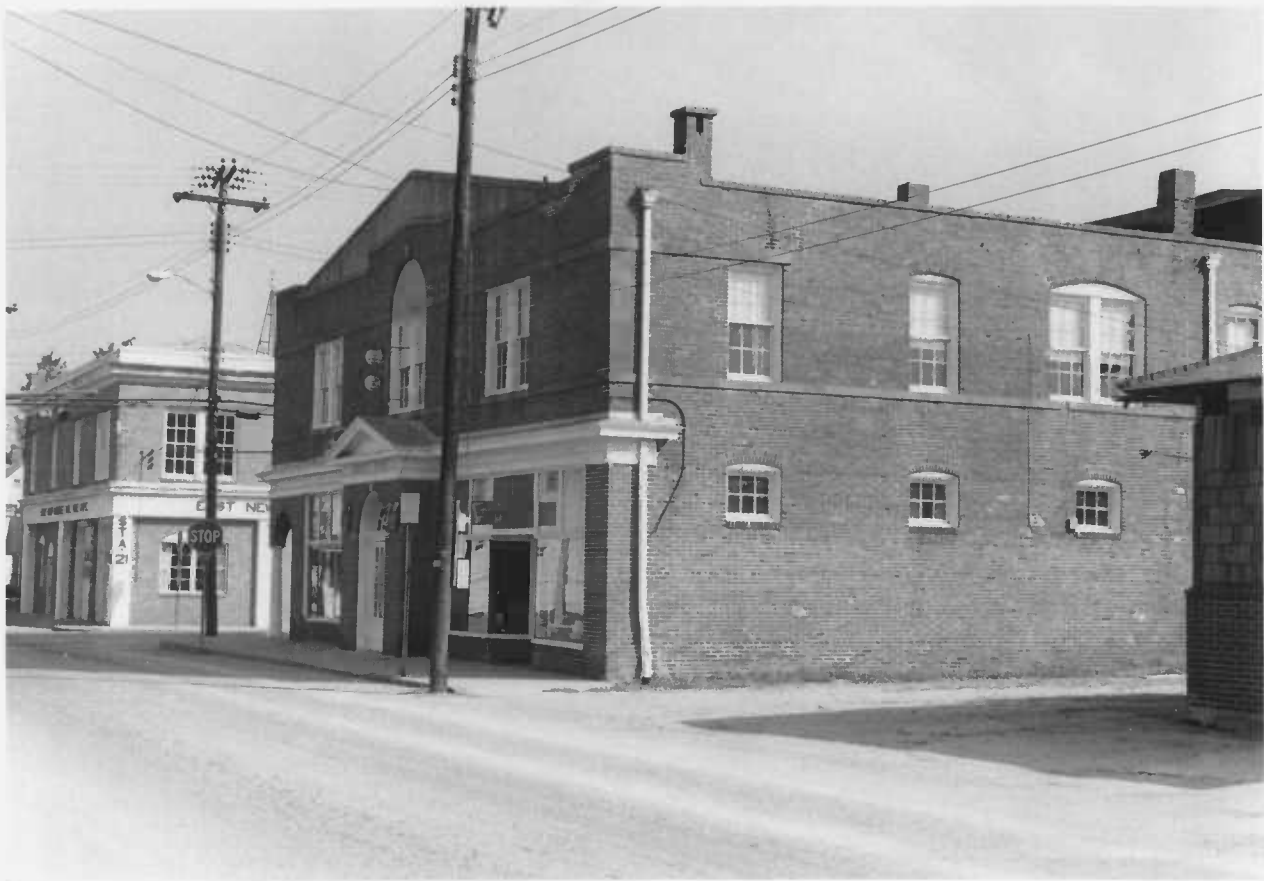
Southwest elevation

The south side, on the other hand, is marked by an asymmetrical fenestration with a series of six-pane windows topped by segmental arches which light the first floor. A concrete stringcourse extends around to the south side and lines up with the bottom edge of the second floor six-over-six sash windows. Towards the back (east) end of the building the elevation rises slightly to a taller two-story structure. A service entrance pierces the south wall of the rear section.
